# Manhole Inspection Summary

Manhole # S27I\_\_025MH

**Inspection** ☐ Is Incomplete Rating: **3) Fair**

**Location** Address: **111 S Schroeder**

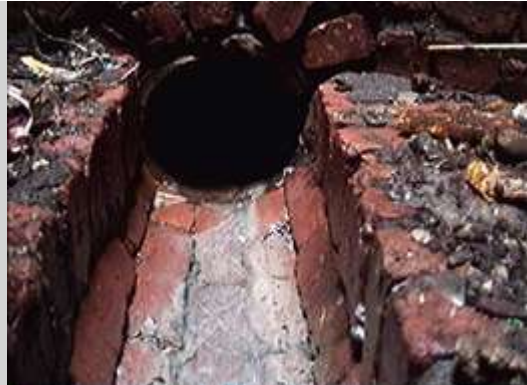
12 O'Clock Outflow

8 in. Circular Gravity Sewer  
Pipe Out @ 12 O'Clock

Pipe Height: **8.4** (in.) Rod and Bar (Angled)  
Pipe Material: **Clay** ☐ Pipe Lined  
Invert Depth: **12.59** (ft.) Flow Characteristics: **Fast**  
Deposits: ☒ None ☐ Mud ☐ Sludge ☐ Debris ☐ Grease  
Silt Depth: **0** (in.) Deposits Extent:  
Infiltration: **None** Pipe Seal Cond: **Sound**

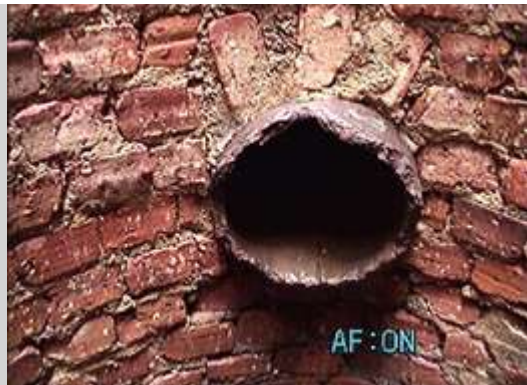
6 O'Clock Inflow

8 in. Circular Gravity Sewer  
Pipe In @ 6 O'Clock

Pipe Height: **8.4** (in.) Rod and Bar (Angled)  
Pipe Material: **Clay** ☐ Pipe Lined  
Invert Depth: **9.33** (ft.) Flow Characteristics: **Slow**  
Deposits: ☒ None ☐ Mud ☐ Sludge ☐ Debris ☐ Grease  
Silt Depth: **0** (in.) Deposits Extent:  
Infiltration: **None** Pipe Seal Cond: **Sound**

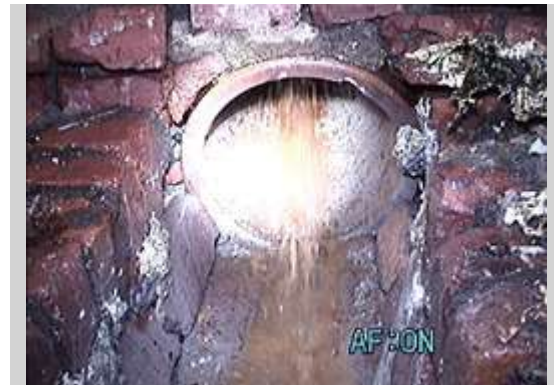
Drop In @ 6 O'Clock

Drop: **Inside** Rod and Bar  
Angled: **Yes** Reading: **11.47** (ft.)  
Inv Depth: **12.47** (ft.)  
Drop Condition: **Open**
